3. <u>ISSUES AND OPPORTUNITIES</u>

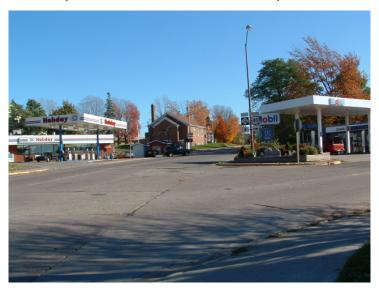
Photo 4: The US-45/Greenland Road (five corners) intersection, showing the planter and sign that impact visibility, and gas station parking lot that is utilized by traffic cutting through to Steel Street.

1. US-45/Greenland Road Intersection: One primary problem area identified within the corridor is the intersection of US-45 and what is now M-38. The intersection is sometimes known as the "five corners" intersection, although through traffic on Steel Street was eliminated in 1996. This intersection has limited sight distance for motorists on US-45 looking east along Greenland Road, due to rising terrain, and a planter and signs at the Mobil station. Westbound traffic on Greenland Road is traveling down a hill when approaching this intersection, and the view of traffic on US-45 can be obscured. During the winter months, snow piled along the roadways can exacerbate these visibility issues. The

planter with its profusion of signs and shrubs inhibits snow removal which is necessary to maintain sight distance. Traffic on US-45 must turn either left or right. A landscaped barrier prevents traffic from crossing the intersection so drivers wishing to access N. Steel Street or East River Street sometimes cut through the parking lot of the Holiday gas station. Tin Street, which intersects with River Street (US-45) just west of the US-45/Greenland Road intersection, is а one-way street with southbound traffic only, meaning

Cutting down the snow banks poses the risk of significant damage to the landscaping materials. Access management issues include the high number of drives and proximity of

these gas station entrances to the intersection, lack of access to areas north of River Street, sight distance, and traffic using the Holiday gas station parking lot as a through street.
